## EVALUATION OF UNPAINTED WEATHERING STEEL BRIDGES IN IDAHO

## Evaluation of Unpainted Weathering Steel Bridges in Idaho

**FINAL REPORT  
FHWA-ITD-RP117**

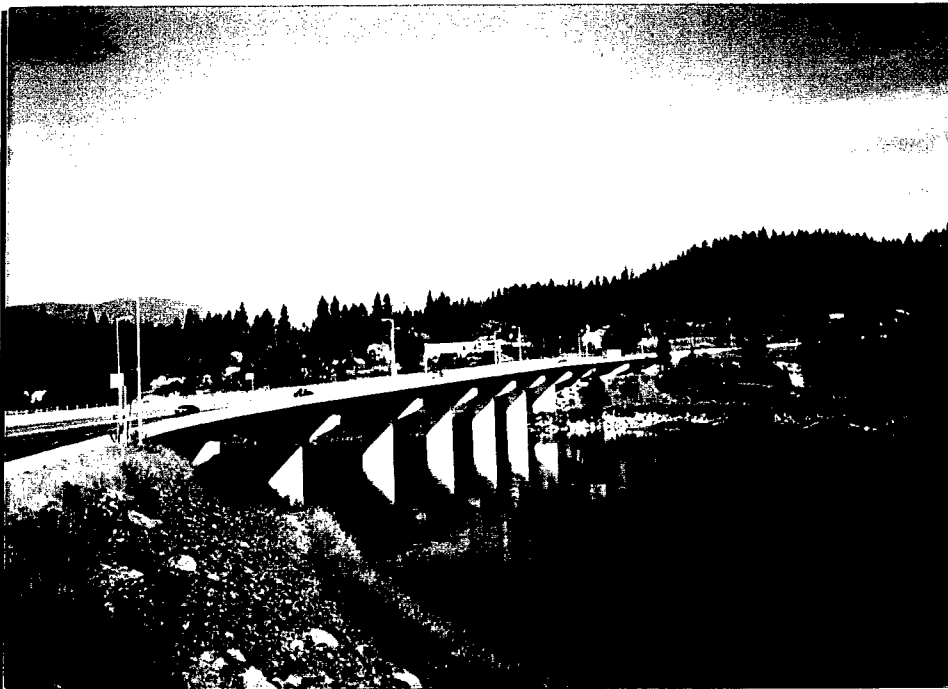
Photo No. 1  
View of upstream side  
from south approach

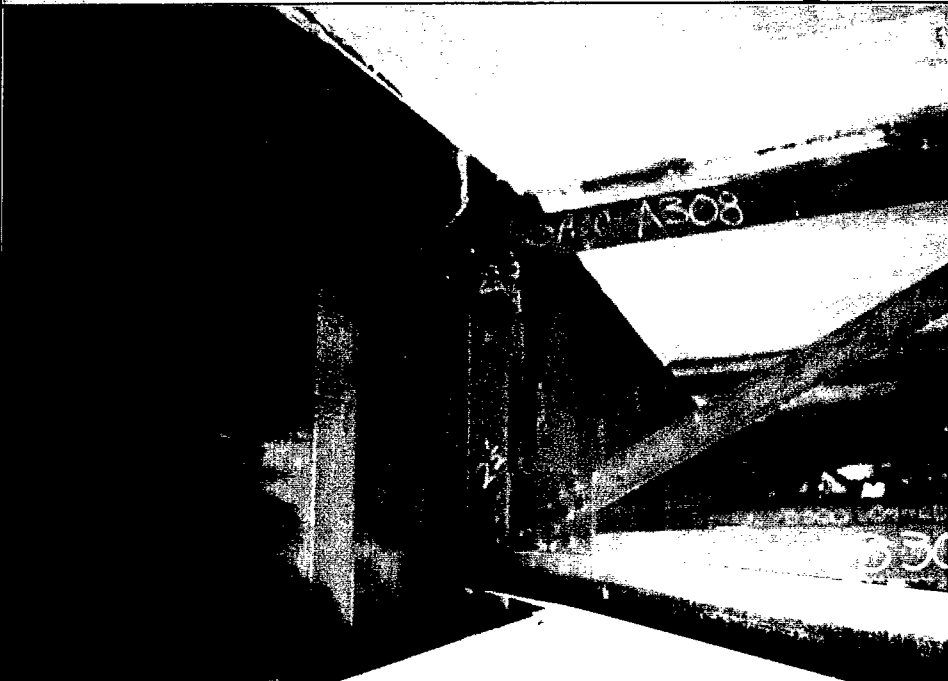
Photo No. 3  
View of interior bay  
showing cross frames and  
lateral bracing. Note mill  
scale and non-uniform  
appearance

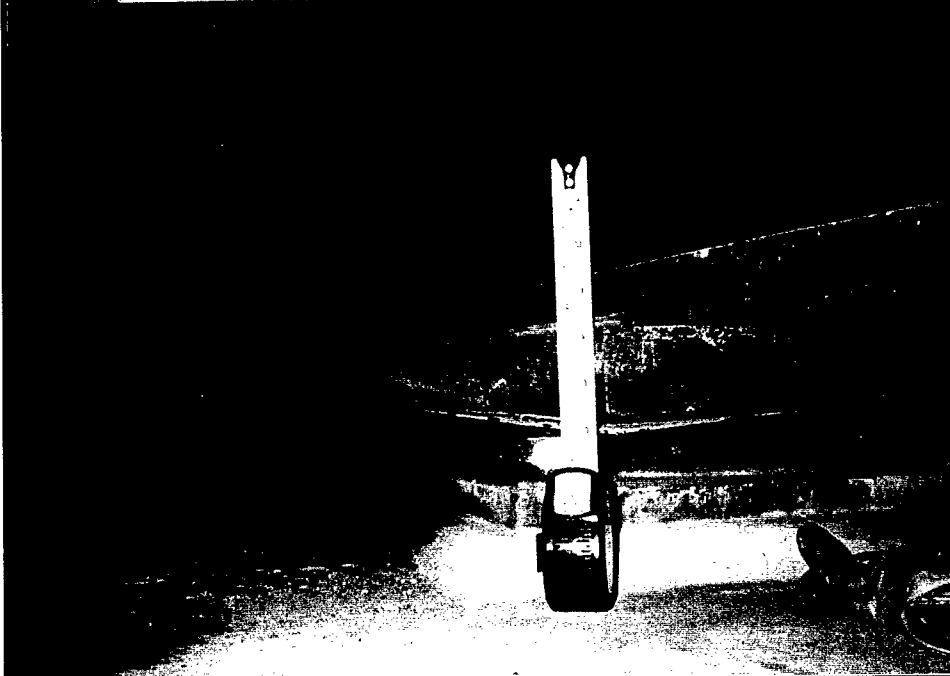
The Bonners Ferry Bridge and the Ninth St. Bridge have guided sliding pot bearings. Corrosion was found on all bearings at both abutments on the Bonners Ferry Bridge. It appears that pack rust has formed between the stainless steel sheet and the upper plate, forcing the stainless sheet to separate from the upper plate. Also the TFE sheet is loose on the south girder at the north abutment and is coming out. The upper bearing plate has some corrosion. Repair or replacement of this bearing should be given high priority.

Photo No. 5  
Expansion pot bearing at  
abutment. Note stainless  
sheet has come loose  
from upper plate.

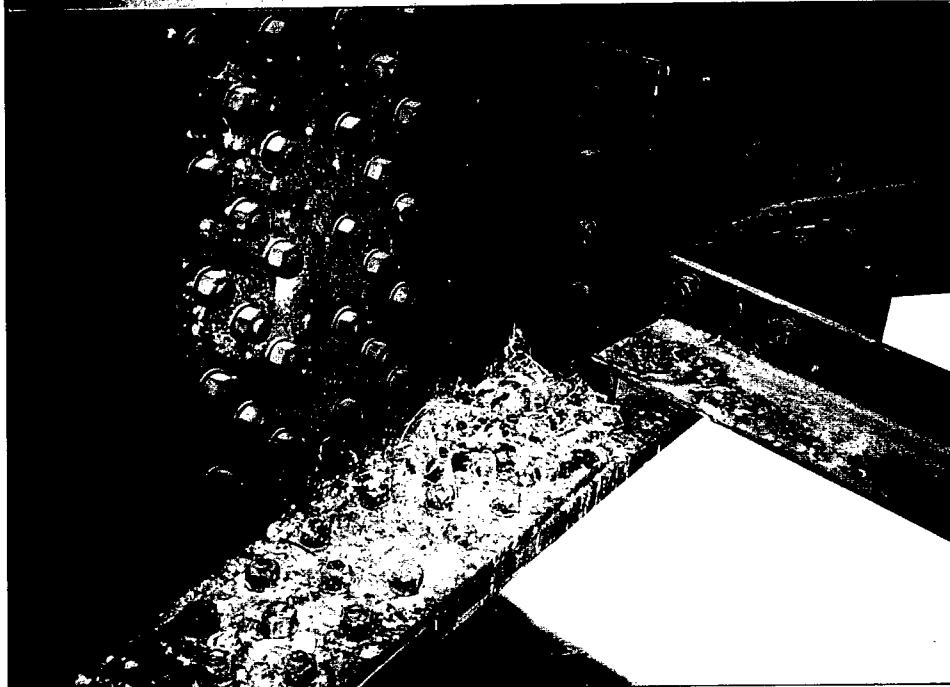
Photo No. 6  
Bird nest on bottom  
flange at cross frame  
connection.

In order to prevent additional corrosion, it is important to remove all bird nests and accumulations of debris on all steel surfaces. ITD's Reachall has recently been outfitted with a high-pressure washer. This equipment can provide access to all areas of the bridge superstructure for cleaning of beam seats and steel surfaces. It is expected that a program to clean all Idaho weathering steel bridges will be implemented in 1996.

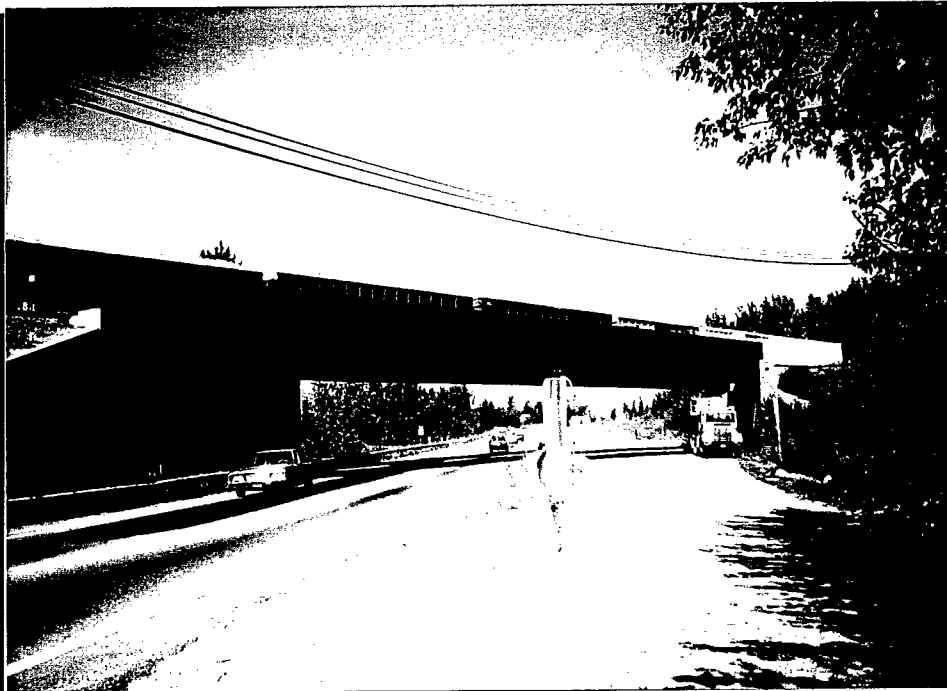
Photo No. 19  
View looking north.  
Note uniform dark brown  
color.

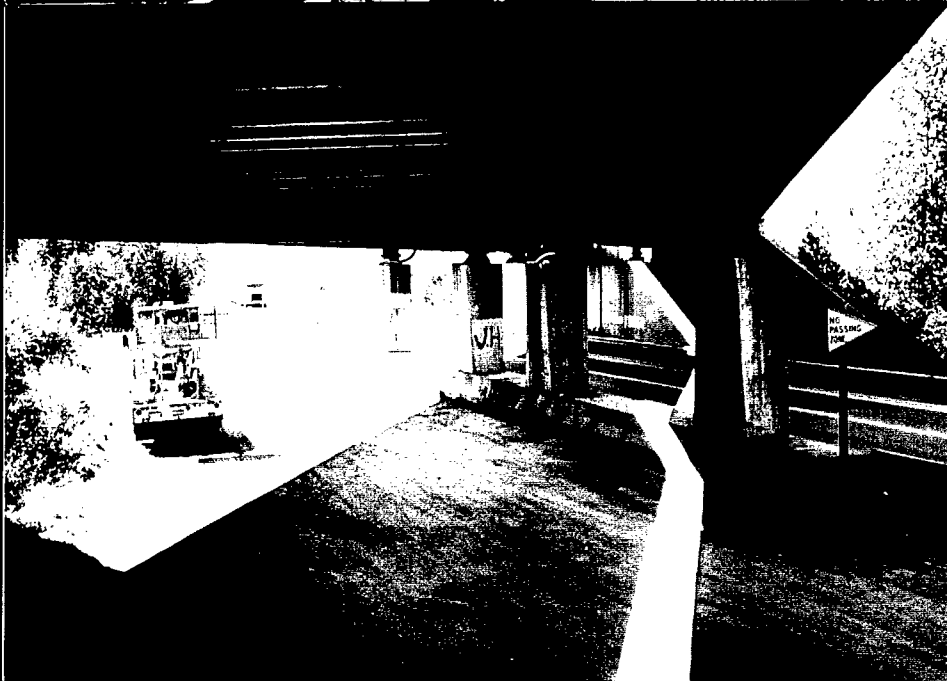
STAINING OF SUBSTRUCTURE: The most notable staining of substructure concrete surfaces was found on the piers of the Ponderay Underpass and the Snake River Bridge near American Falls. Both of these bridges were built more than twenty (20) years ago and well before ITD had adopted current practices to minimize staining. Neither bridge had drip plates (water deflector plates) on the bottom flanges. Also there was no requirement to protect surfaces of the substructure from staining by wrapping with plastic or other approved material until deck placement has been completed.

Photo No. 21  
View from East Abut-  
ment. Note staining on  
pier columns.

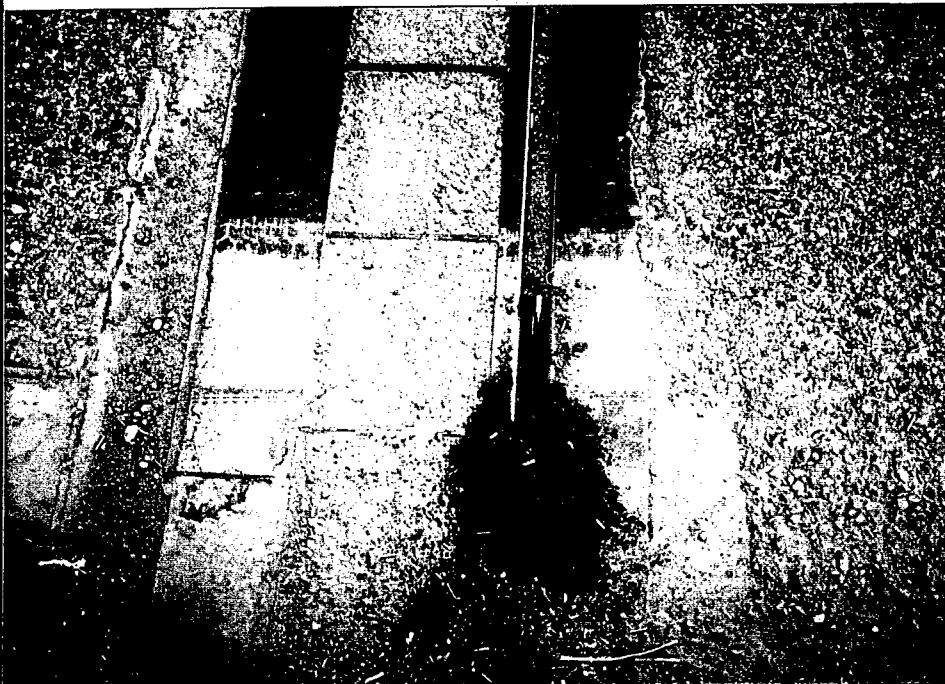
The NW Caldwell IC has a strip seal joint at each abutment. The joint at the west abutment is leaking, but water is not getting on the steel members, and no corrosion was found. The seal is about 3 inches below the deck surface and is full of dirt and sand. This type of joint requires frequent cleaning.

Photo No. 27  
Top view of deck  
expansion joint at  
Abutment 1. About 3" of  
sand and dirt is in joint.

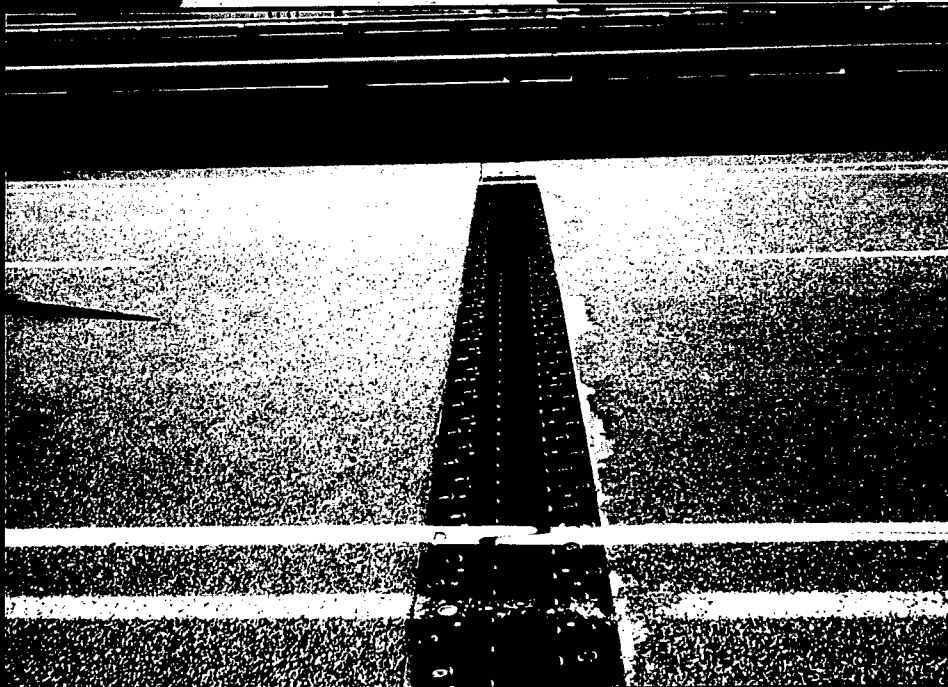
Photo No. 32  
Top view of deck  
expansion joint at Pier 3.  
Note asphalt seal on  
the deck.

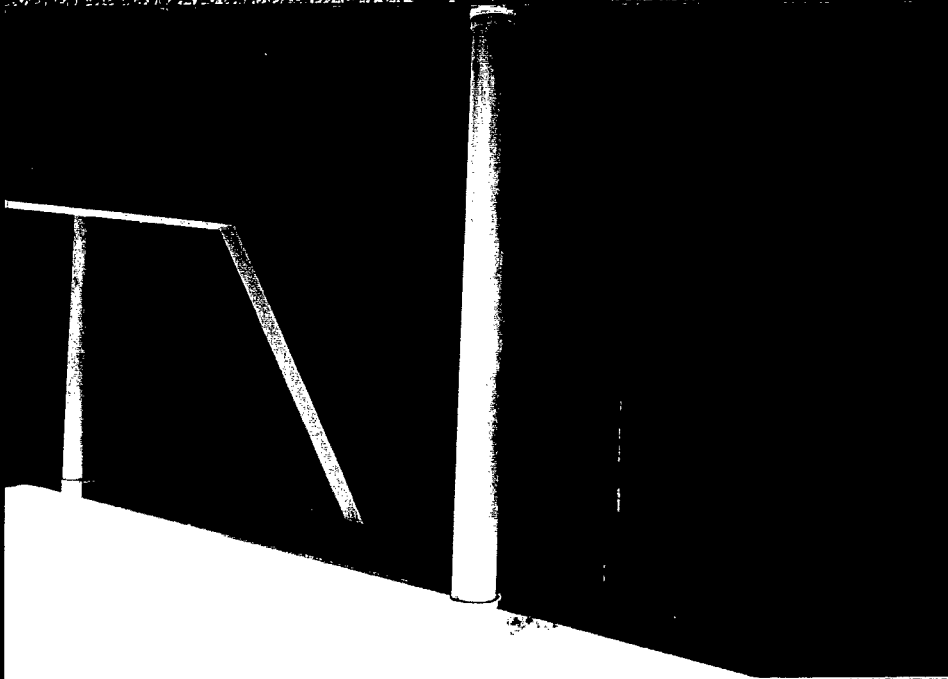
Photo No. 33  
View of interior face of  
girder. Note drainpipe  
from trough under the  
deck joint

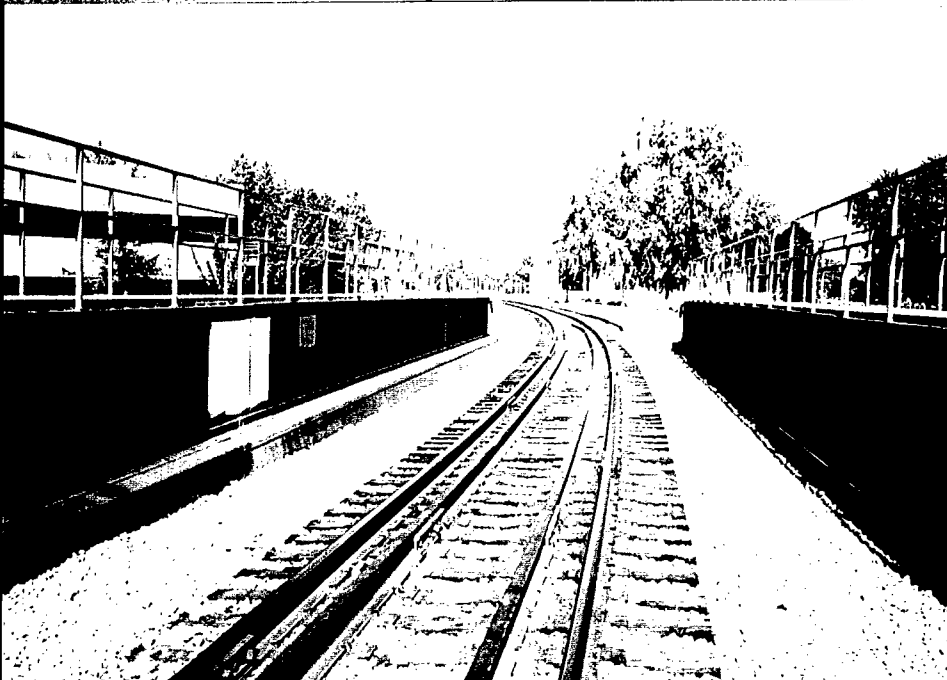
Photo No. 44  
Top view looking west,  
showing tracks and  
ballast. Note the paint  
patches covering grafitti.

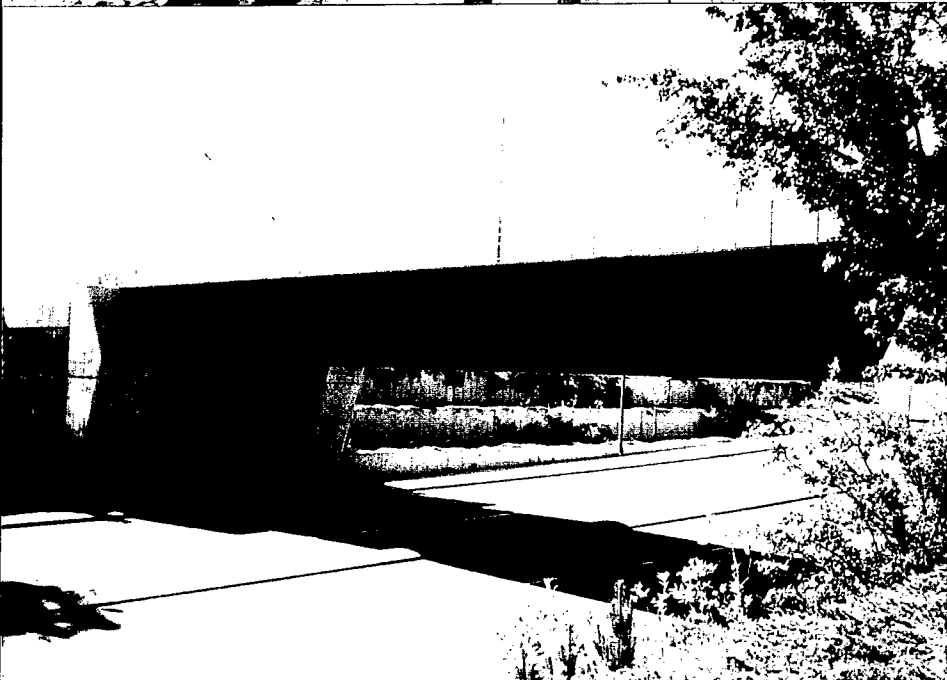
Photo No. 45  
View of north girder.  
Note vertical stains at top  
flange breaks.

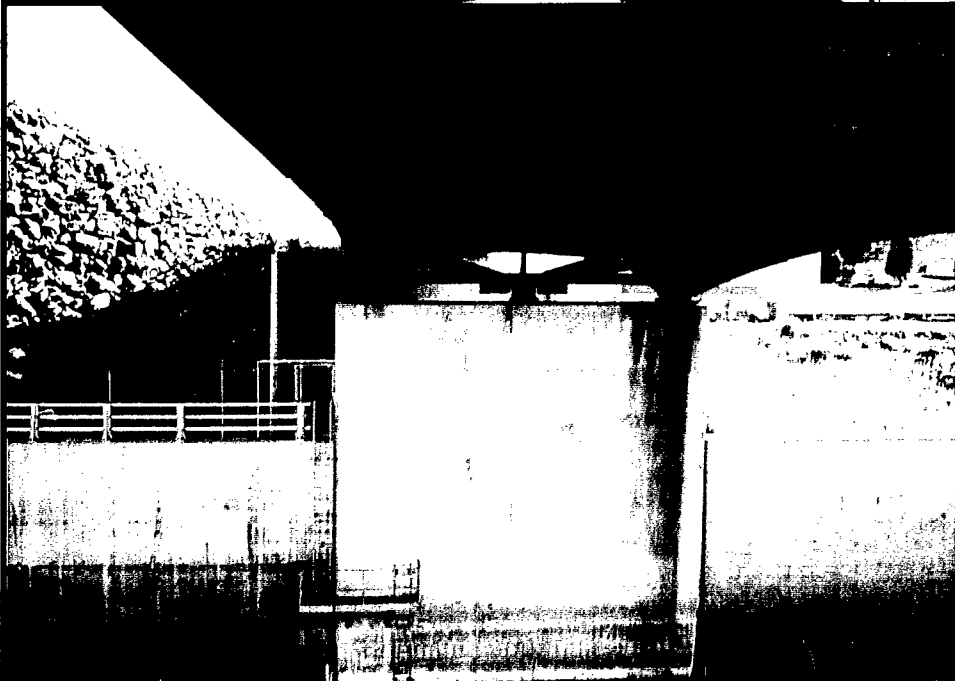
Photo No. 57  
View of Pier 6 with dark  
stains showing on pier  
under south girder.

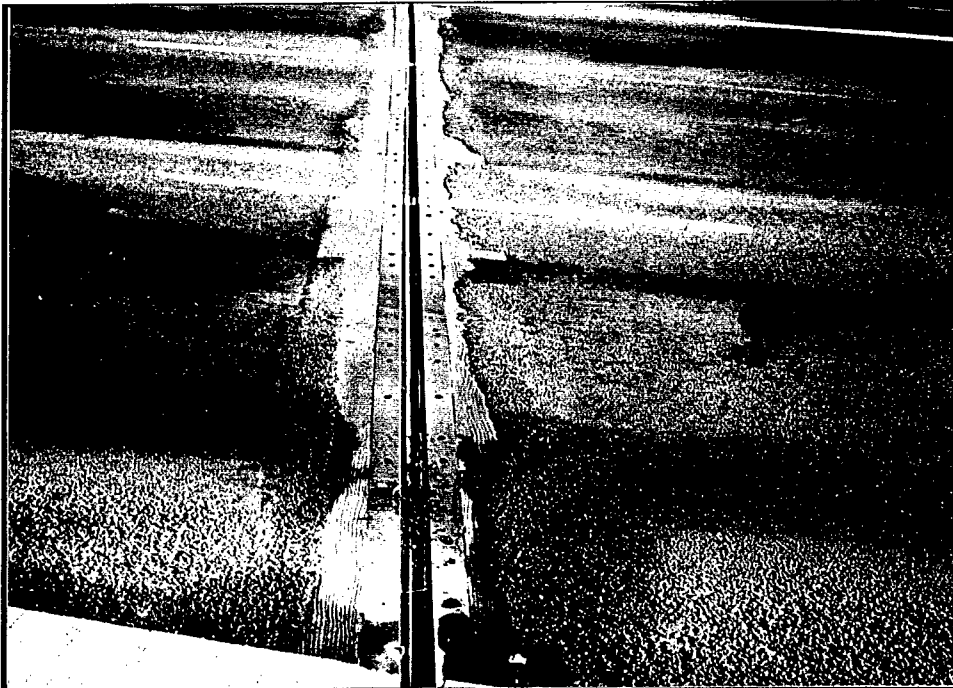
Photo No. 64  
Top view of deck  
expansion joint at pier.  
Note the asphalt chip seal  
on the deck.

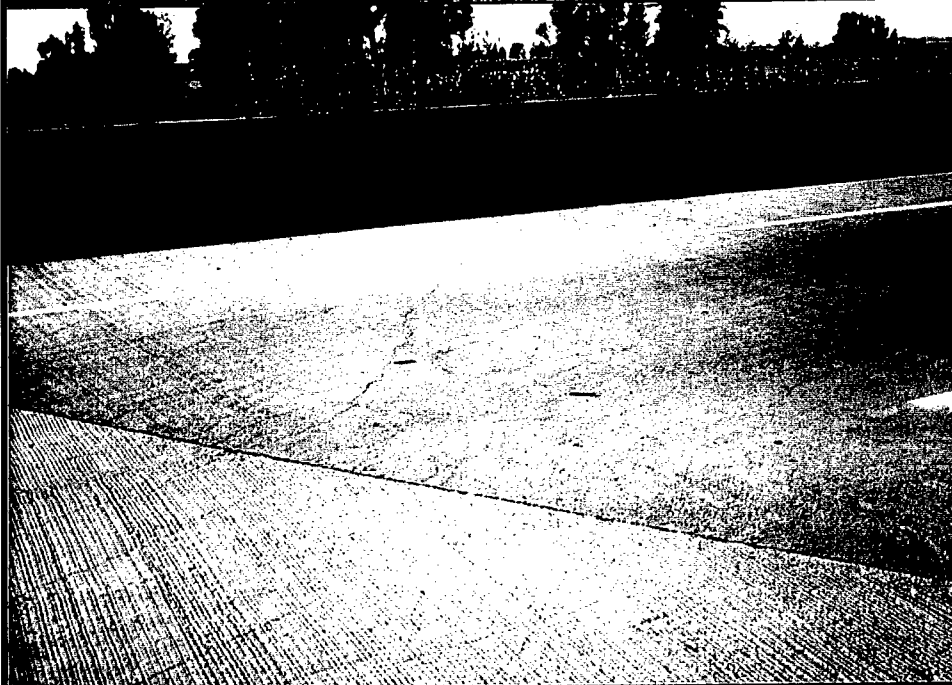
DECKS: The concrete decks on the inspected bridges were found to be in good condition. Most decks had minor hairline transverse cracks. Random cracking in the top of the deck was observed on the South Fork Teton River Bridge. No evidence of roadway drainage water leaking through deck cracks and onto the steel was observed.

Photo No. 67  
View of top deck and  
approach slab. Note the  
cracks.
